GE Vernova Shares How a Custom-Built, Large-Capacity Runout Inspection Table Helped Speed Up Rotor Repair & Assembly

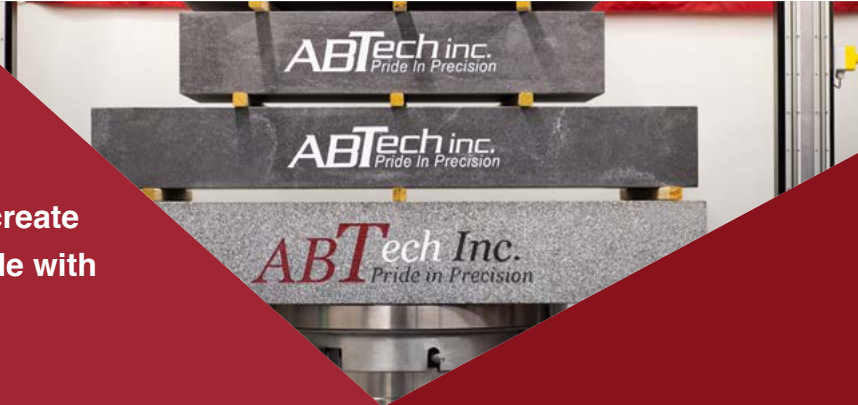
GE Vernova teamed up with ABTech to create a custom-built, large-capacity rotary table with 0.25 μm accuracy.

ABTech designed and constructed a rotary table with an impressive three-foot granite platform foundation; it supported a 35,000-lb load and offered a 0.25 μm rotational accuracy. The table’s hydrostatic oil film bearing technology was key to achieving the required high load capacity, extreme stiffness, and ultra-smooth sub-micron motion.

GE could use the new rotary table to check the roundness and flatness of large-scale turbine parts, which helps determine how to position individual components in order to assemble a rotor as close to truly straight as possible.

By collaborating with ABTech, GE ensured the rotary table could merge with the newly built inspection measurement arms. Joining these two technologies—ABTech’s high-capacity rotary table and the measurement arms—gave GE a dedicated run out inspection table for streamlining their turbine repair & assembly process.
